## DURABILITY AND BEHAVIOR OF PRESTRESSED CONCRETE BEAMS

Report 4

POSTTENSIONED CONCRETE BEAM INVESTIGATION  
WITH LABORATORY TESTS FROM JUNE 1961 TO  
SEPTEMBER 1975

Edward F. O'Neil

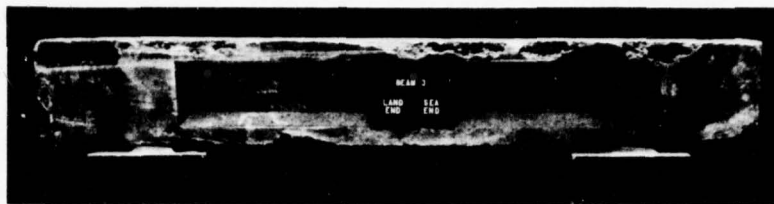
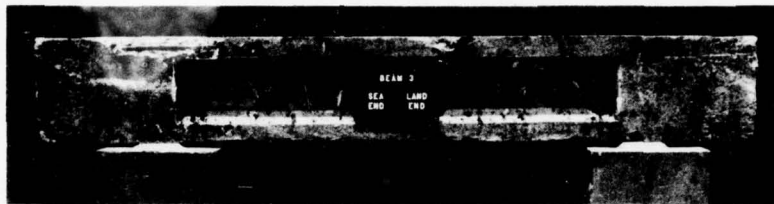
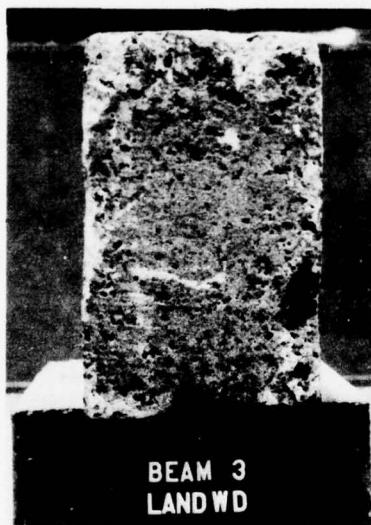
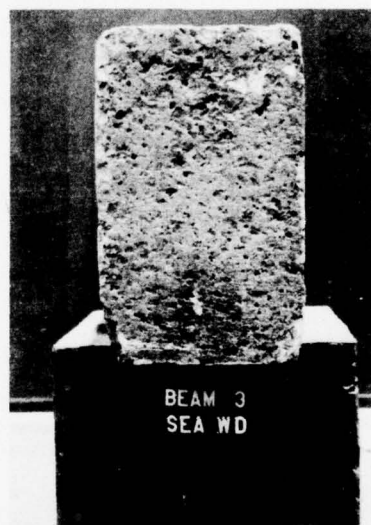
Figure 3. As-received condition of beam 3

33. The as-received condition of beam 3 is shown in Figure 3. Concrete had spalled from the conventional reinforcement in several

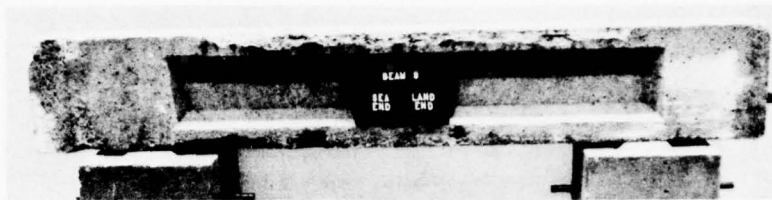
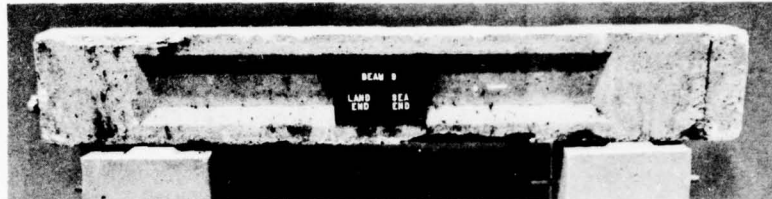
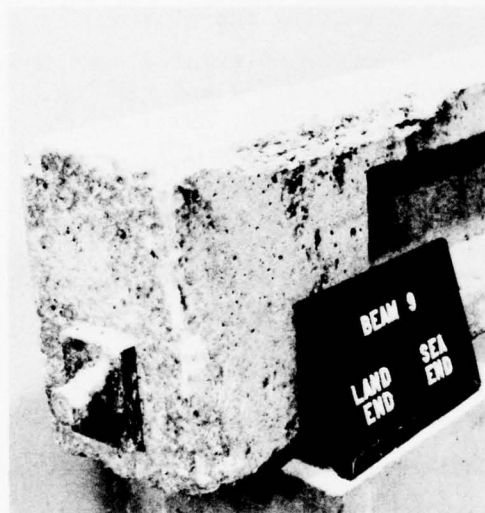
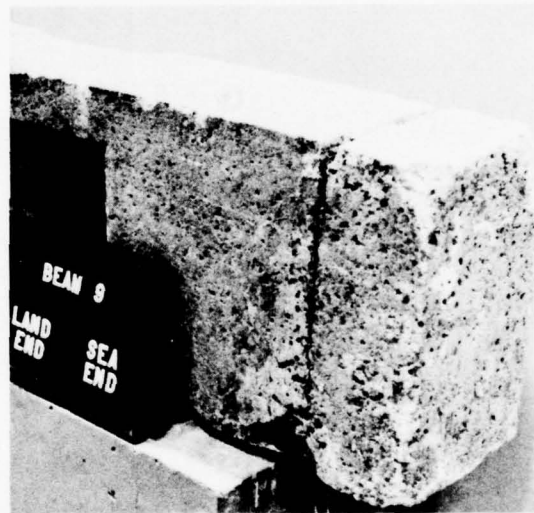
Figure 5. As-received condition of beam 9

47. The as-received condition of beam 9 is shown in Figure 5.

The concrete cover had spalled from much of the conventional reinforcement exposing it to the corrosive environment. The end anchorage protection cap (Figure 5d) of the seaward end remained intact but was chipped and damaged at the joint. Figure 5c shows the condition of the

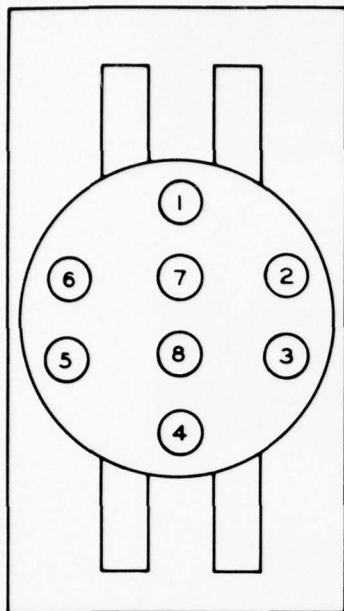
Figure 7. Landward end anchorage, beam 13

with heavy tarnish and pitting. Most of the rusting was concentrated in the area of the plate through which the strands passed.

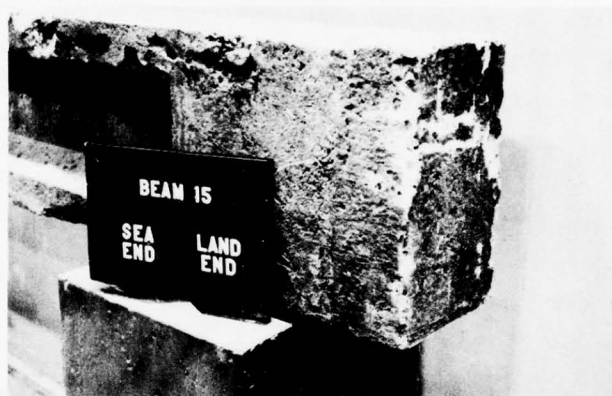
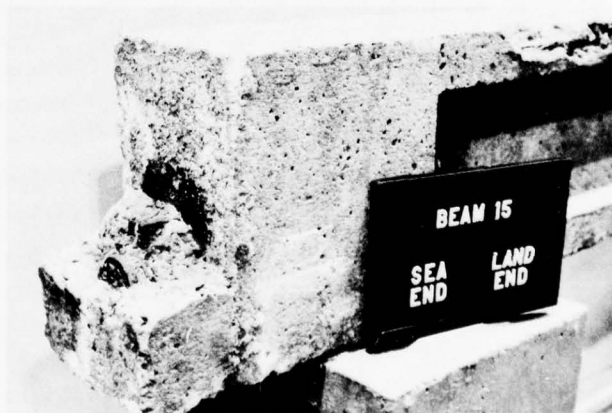
Figure 8. As-received condition of beam 15

68. The as-received condition of beam 15 is shown in Figure 8. Heavy spalling occurred on one side of the beam only and mainly at the top of the beam. The spalling at the top seaward end exposed the conventional reinforcement caging.

69. The landward end of beam 15 was protected by an external air-entrained concrete cap. The concrete of the beam at this end had a set-retarding agent added to aid in the bonding of the protective cap. This end protection (Figure 8c) was intact and had not developed any bond cracks at the time it was received.

70. The seaward end of this beam was protected by an air-entrained concrete cap that was bonded to the main beam by an epoxy adhesive between the beam and protective cap. As shown in Figure 8d, part of this cap broke away from the beam, exposing the end anchorage to the environment.

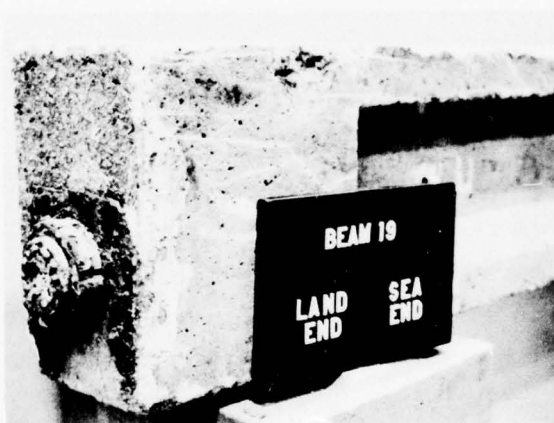
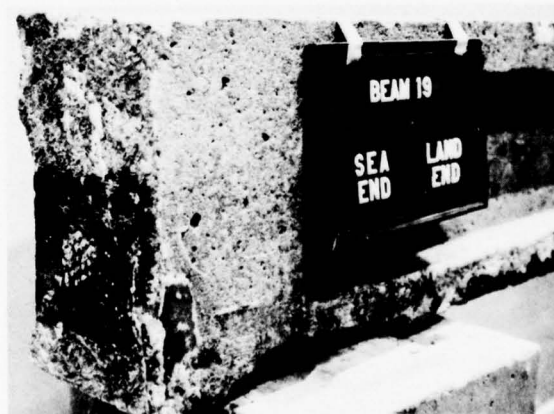
Figure 9. As-received condition of beam 19

86. The as-received condition of beam 19 is shown in Figure 9. Concrete had spalled from only one edge, exposing the conventional reinforcement at two places. The remaining three edges did not have any spalling present.

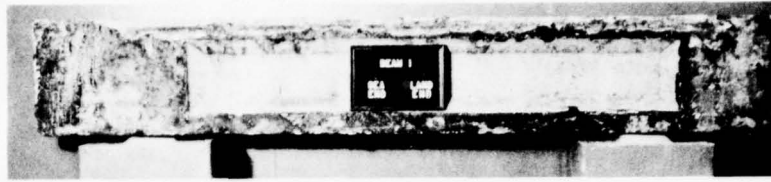
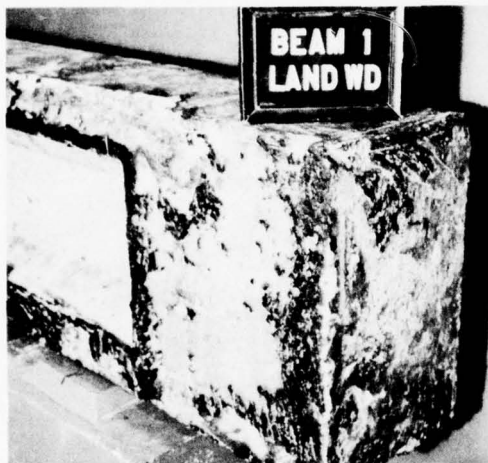
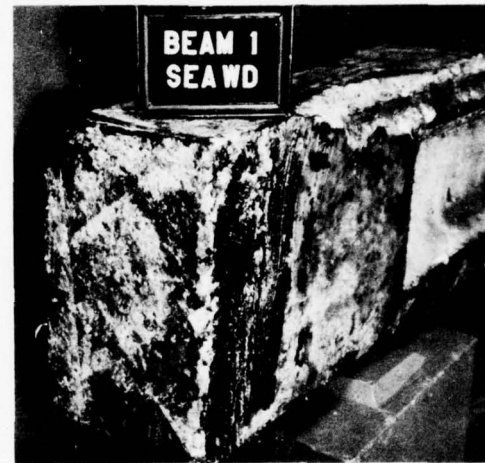
Figure 13. As-received condition of beam 1

107. The as-received condition of beam 1 after the bituminous membrane had been removed is shown in Figure 13. Some of the concrete had spalled from the top edges of the beam exposing the conventional reinforcement at the seaward end on one side (Figure 13b) and along most of the top edge on the other (Figure 13a). Both end protective caps were still intact and did not show excessive wear.

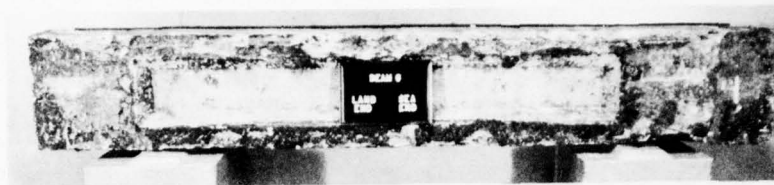
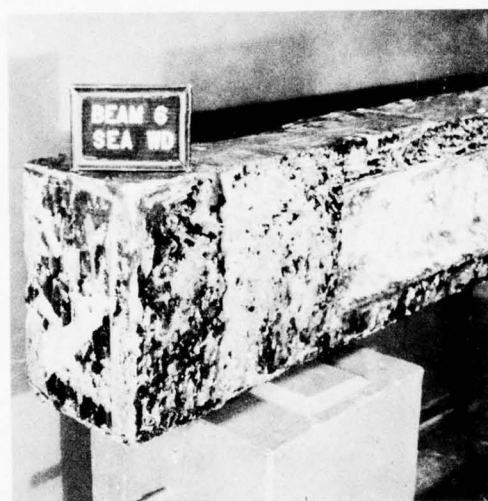
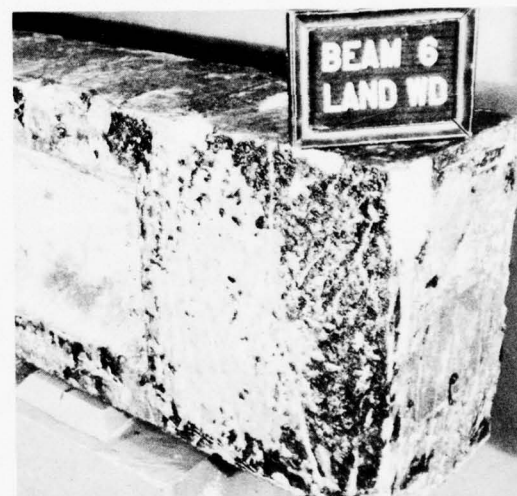
Figure 15. As-received condition of beam 6

118. The as-received condition of beam 6 after the removal of the protective bituminous membrane is shown in Figure 15. Comparison of the two sides shows that spalling occurred only on one side at the top edge of the beam. Figures 15c and 15d show the conditions of the landward and seaward end protective caps.

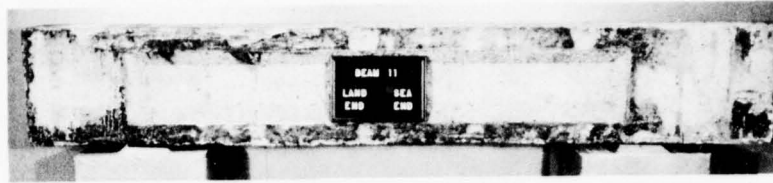
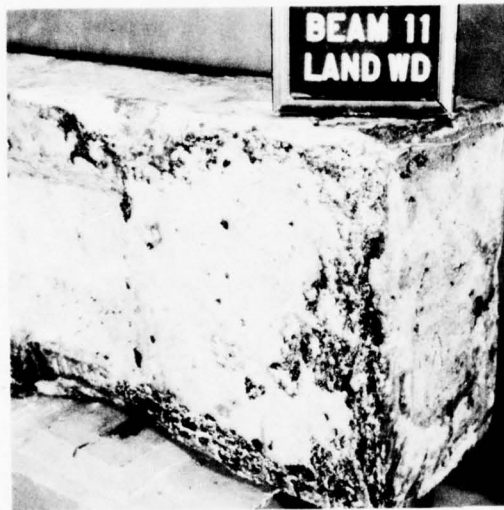
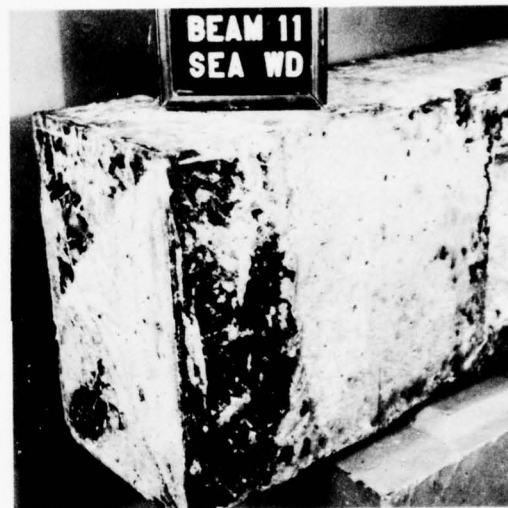
Figure 16. As-received condition of beam 11

129. The as-received condition of beam 11 is shown in Figure 16. The concrete had spalled from the top edges on both sides of the beam and from one side at the bottom, exposing the conventional reinforcement to saltwater attack. The beam had a protective end cap at the seaward end and a plug over a flush end anchorage at the landward end. Both types of end protection were in excellent shape at the time of inspection.

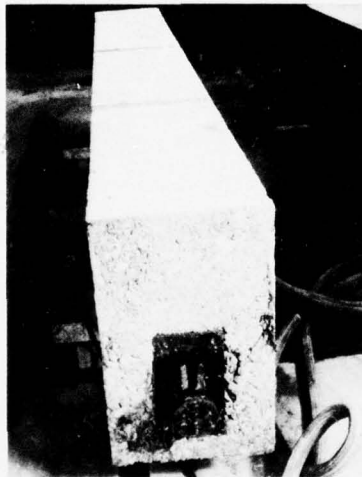
Figure 17. Strands entering beam through the rectangular plate

strands except the concrete protective cap that is cast over the end anchorage system. As shown in Figure 17, the strands enter the beam through the large rectangular plate. There is no pressure fit of the button head at this point. Consequently, water and oxygen can travel along the strands and into the conduit. Photos 11 and 14 show the inside surface of this type anchor plate with the corrosion around the holes. This was the only instance in which the inside face of an anchor plate was corroded in the middle.

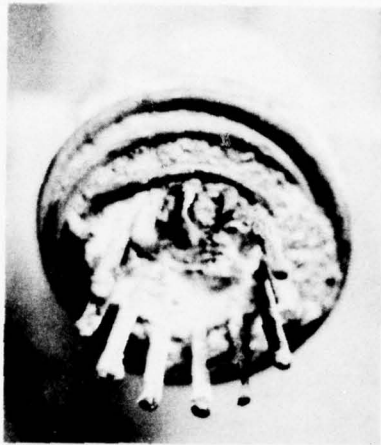
37. Using the nomenclature in Figure 4, the steel strands that protruded from the end of the anchorage were corroded (Photo 1) as follows:

Photo 1. Corrosion to strands of the landward end anchorage of beam 3

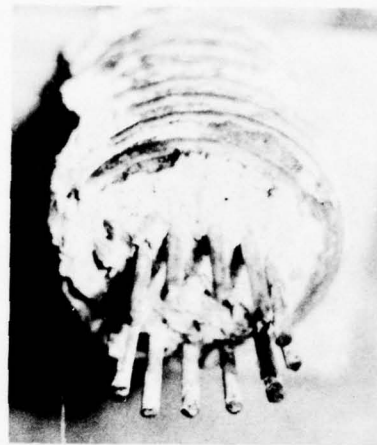
46. The coil of steel around the concrete that made up the end anchorage was likewise free of rust and mildly pitted (Photo 2).

Photo 2. Condition of steel of the seaward end anchorage beam 3

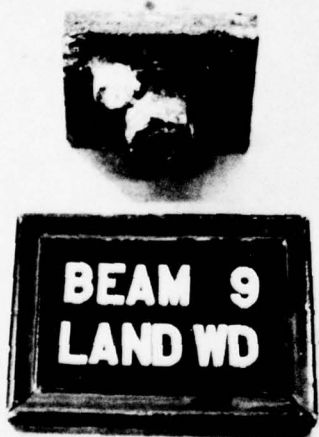
49. The outside of the landward end anchorage plate (Photo 3) was heavily rusted. The entire face of the anchor plate, as well as the threaded end of the posttensioning rod, the washer, and the bolt used to tighten the rod, was corroded. The anchor plate was covered with a thin layer of unsound rusted metal. Parts of this layer had flaked away, and the sound metal below was covered with rust.

Photo 3. Heavy rusting to outside of the landward end anchorage plate in beam 9

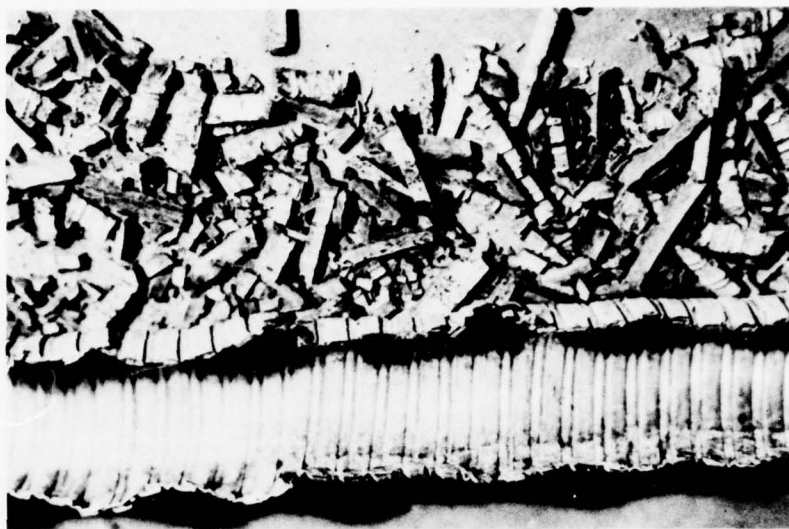
Photo 5. Grout from the landward end of conduit  
in beam 9

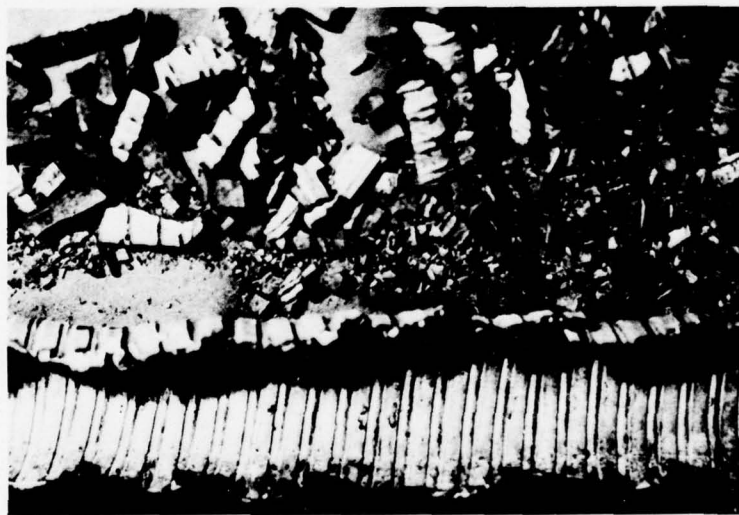
Photo 6. Grout pieces from bottom of conduit  
in beam 9 thicker and more elongated than those  
from top of conduit due to thicker grout cover  
on bottom

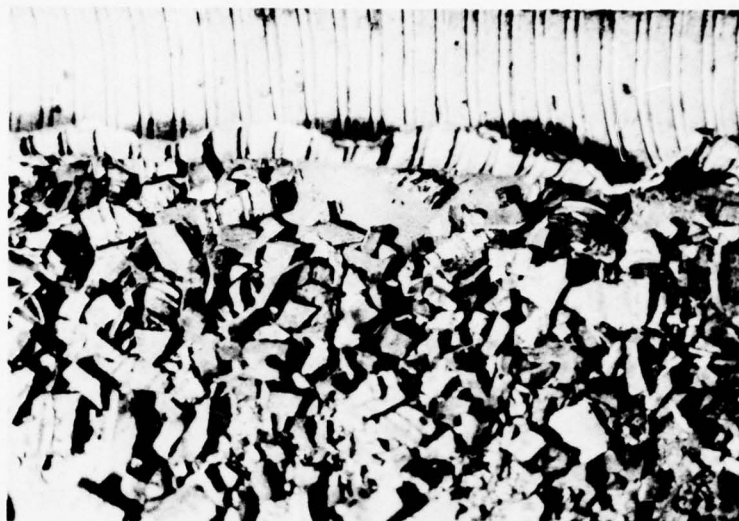
Photo 7. Central section of bottom of conduit in beam 9 and its pieces of grout

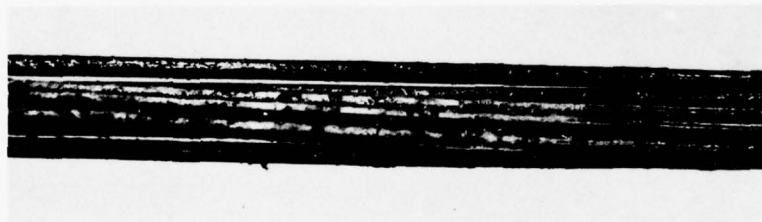
Photo 13. General view of strands in beam 13 showing  
rusted areas, and moist and dry grease

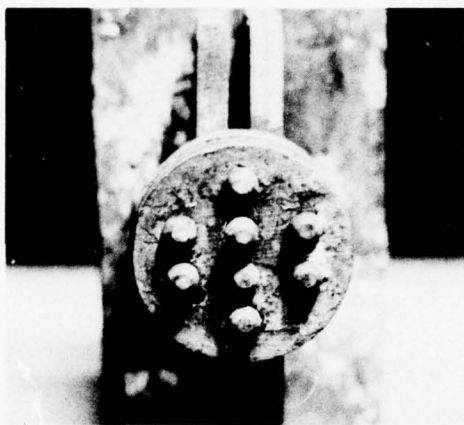
67. The round anchorage plate and the ends of the strands were heavily rusted, both on the outside surface and the edges. The two spacer bars were lightly to moderately rusted, with most of the rust occurring on the edges of these plates. The areas on these plates that were not rusted were heavily tarnished and exhibited some pitting (Photos 15 and 16). The ends of the strands that were outside the beam

Photo 15. Heavy rusting to round anchor plate on outside face of the seaward end of beam 13

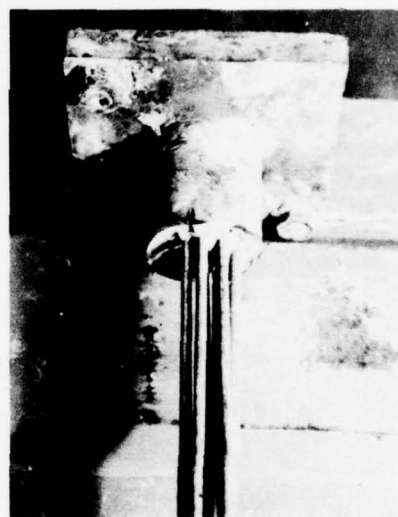
104. The inside face of the plate was not rusted at all. The metal surface was heavily tarnished, as were the edges, with some moderate pitting of the metal but no rust (Photo 38).

Photo 38. Inside face of the seaward end anchorage plate in beam 19. Note heavy tarnishing and moderate pitting but no rust

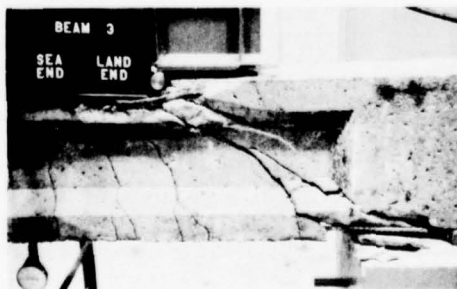
Photo A2. Failure condition of beam 3

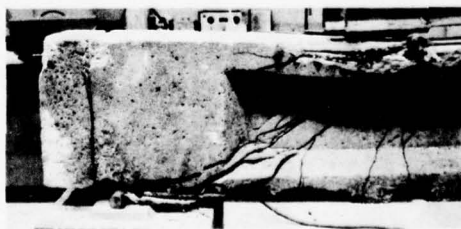
Photo A4. Failure condition of beam 9

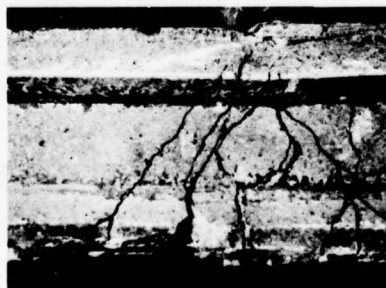
Photo A6. Failure condition of beam 13

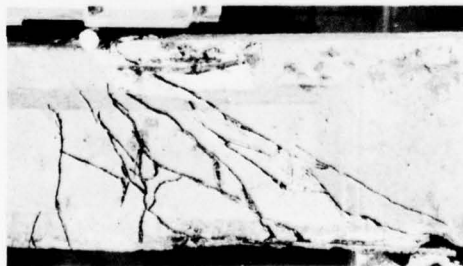
Photo A8. Failure condition of beam 15

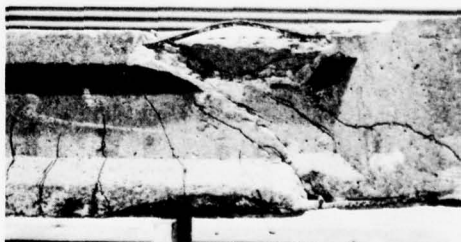
Photo A10. Failure condition  
of beam 19

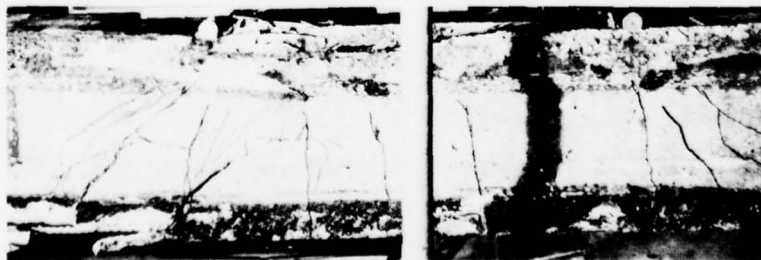
Photo A12. Failure condition of beam 6

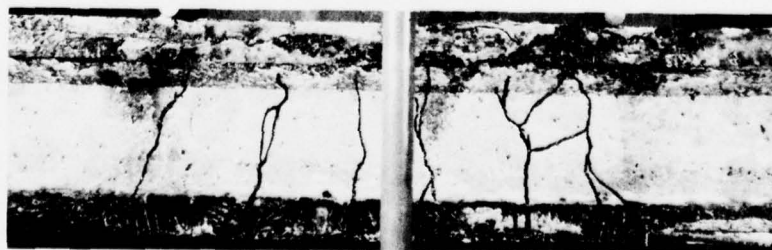
Photo A14. Failure condition of beam 11
